Original Article

Evaluation of Setup Errors in Two Radiotherapy Centers from a Physicist's Point of View

Keyvan Jabbari¹*, and Nima Rostampour¹

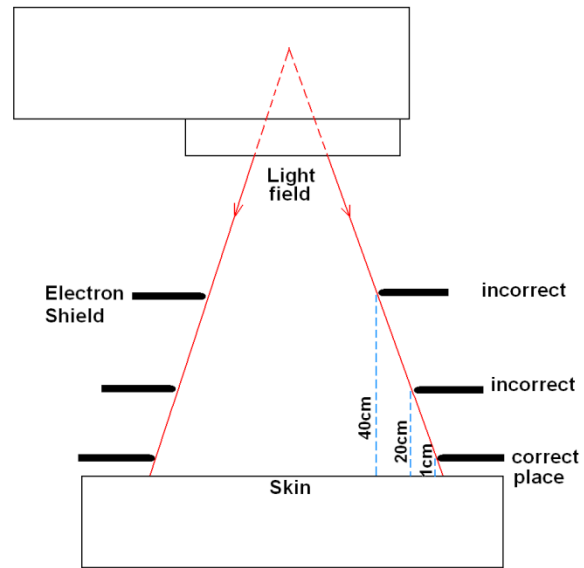
1) Shielding: There were mistakes in photon and electron shields. An important error in shielding was due to improper placement of the shield by the technician. This occurred for the electron shielding, in which the technician used to place the electron shield far away from the patient skin, in a way that the shadow of the shield covers the shielded area (Figure 1). The electron applicators of Neptune Linac consists of lead blades in various distances from the surface. These blades enable one to place the extra shields in various distances from the surface. The distance of the shielding from the surface in this case was 20-40 cm from the patient's skin. This is totally due to the lack of conceptual understanding since despite photons, electrons do not move along a straight line from the source and electrons have a large lateral scattering [15]. It should be noted that the technician was aware of the fact that the electron shield should be placed close to the surface and this mistake was due to carelessness. This could cause two problems: overdose of the shielded normal tissue and underdose of the tumor [16-19]. The distance of the electron shield should not be more than 1 cm away from the skin. The setup for film dosimetry experiment for evaluation of this error is illustrated in Figure 1. In this experiment, three EDR2 films were placed on the surface of the PMMA phantom and the 3 shields were placed in 1, 20 and 40 cm distances from the surface according to the light field of the Linac. Each time 150 MU were delivered to the films.

Figure 1. Illustration of the conceptual mistake for shielding of the electron fields. In the incorrect cases the electron shield is placed in large distances from the skin (20-40 cm) in the way that the shadow of the shield in the light field covers the shielded area.

a) Impact of distance of shield placement in electron beams: In this error, the technician has placed the lead shield at the large distances up to 20-40 cm away from the surface of the skin in match with the light field of the Linac. The film dosimetry study determined the impact of this

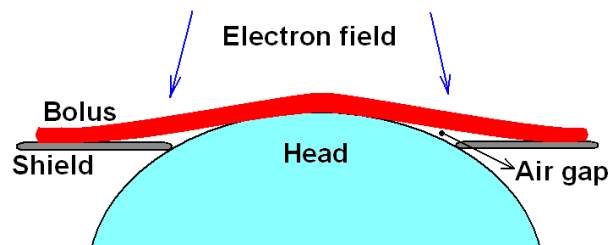
4) Bolus: This error was also due to a conceptual mistake of the technician about the application of the bolus. In few cases, the technician simply placed the bolus on patients head while there were large air gaps between the skin and the bolus (Figure 2).

Figure 2. A sample of occurred error in using of bolus.

b) Air Gap under the bolus: The bolus is assumed to be in touch with the entire surface of the patient with no air gap. This error can cause the underdose of the skin since the bolus usually is used for superficial lesions to maximize the dose to the skin.

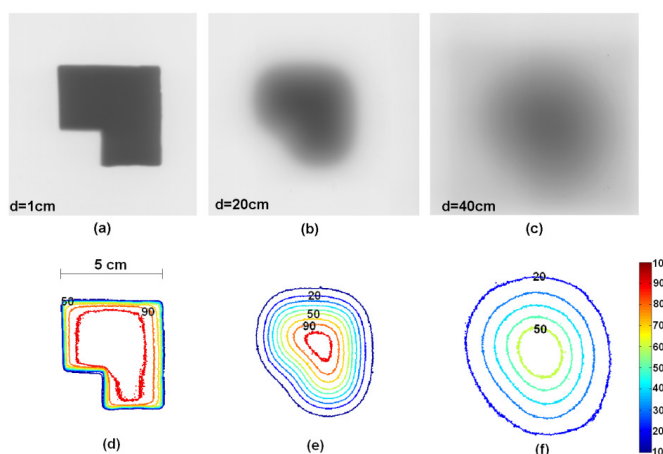
mistake as it is illustrated in Figure 4. The electron energy was 6 MeV and the type of films was Kodak EDR2. In these experiments the electron shields were placed at 1, 20, 40 cm away from the surface of the film while the shadow of the shield was in the correct position covering the shielded area (Figure 1). The films were calibrated, and dosimetry was performed according to Childress et al. recommendations [20-24]. Figure 4 illustrates the irradiated films and related isodose curves.

This error causes the underdose of the treated area up to 50 % and it can also cause the overdose of the shielded area with an amount of 20% of the prescribed dose to tumor. It should be noted that this kind of mistake is not likely to happen in custom made electron shields in which the size and position of the shield cannot be changed. This can happen, for example, in a square field, the corner of which is supposed to be manually blocked with a simple lead block (Figure 4).

Figure 4. The results of film dosimetry for various cases in electron shielding. In Figures a, b, and c the electron shields were placed in distances of 1, 20 and 40 cm from the surface, respectively. Figures d, e, and f illustrate the related isodose curves of the above films.

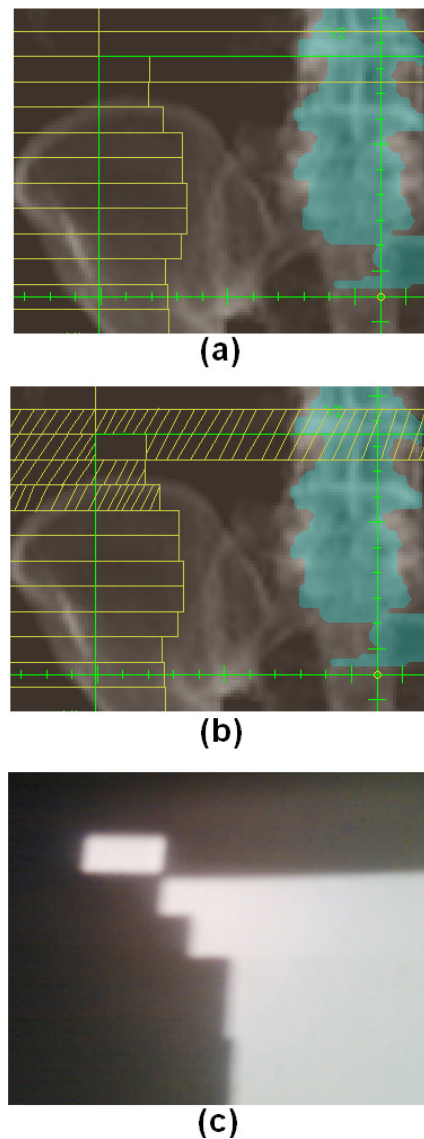
c) Error in MLC shape: An example of this mistake is illustrated in Figure 5. In this error, the jaws are not closed completely and they are not covering the borders of the MLC, therefore there might be an opening of the field by one leaf of MLC at the corners and out of the main field. The size of the unwanted opening in Figure 5 is around $1 \times 2 \text{ cm}^2$. This was the most common and unusual mistakes that were observed in this study. Searching for the reason for this mistake lead us to the way of the field illustration in the treatment planning system as illustrated in Figure 5. b. It should be noted that the hachure is added manually to Figure 5. b to illustrate the opening and the actual illustration is illustrated in Figure 5. a. The projection of the anatomy and the MLC leaves are all in a black background and the physician and physicist can easily miss the open spots in the plan. When the field is projected on the patient, since there is a light and dark shadow one can easily recognize an unwanted opening as illustrated in Figure 5. c. It should be noted that before this evaluation, for months technicians believed that these openings are part of the treatment field and no correction where made.

The worst case of error for MLC shape in this study was a $1 \times 5 \text{ cm}^2$ field that was open right on the spine of a patient beside the main supraclavicular field. The patient was treated 12 sessions with this field. In order to solve this problem, all the technician were trained to inform the physicist upon the visiting of such an error to correct the field size. These cases included the MLC field shapes in which there were small open fields outside the main field, similar to the one shown in Figure 5. c. The number of these errors became lower after the proper training of the technicians about this error.

Figure 5. An example of error in MLC shape. a) This image illustrates how the radiation field looks like in the treatment planning software, where the error in the MLC shaping can easily be missed. b) The positions of the MLC leaves are hachured manually to illustrate the field shape. c) This is the shape of the field size on the patient's skin. The patient was "treated" over 17 sessions with this field size before the errors were observed and corrected.
