Original Article

Evaluation of Setup Errors in Two Radiotherapy Centers from a Physicist's Point of View

Keyvan Jabbari¹*, and Nima Rostampour¹

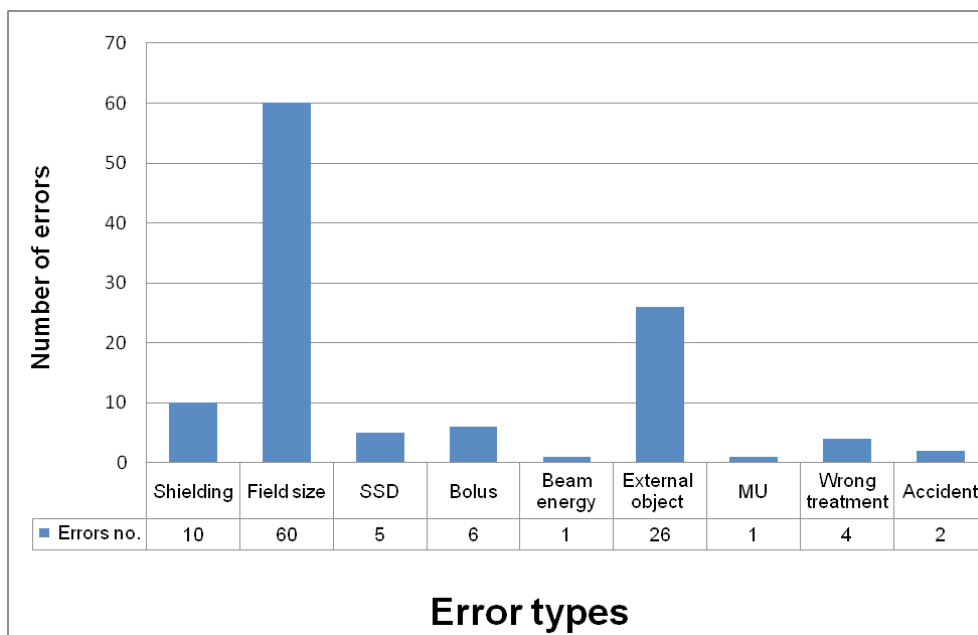
In this study, 115 errors were recorded. This number includes all minor and major errors. Figure 3 shows the distribution of the errors for various categories. The maximum error types were related to field size (60 of 115 cases) and existence of external objects in the radiation field (26 of 115). The details and the consequences of the errors can be evaluated by calculation or measurements. Some of the consequences and causes of mistakes are evaluated as follows:

Figure 3. The distribution of the errors for various categories.
